HANDLING INSTRUCTIONS for DISPENSA VVS-x

KESSEBÖHMER

02/2012

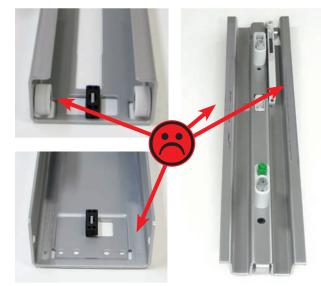
1.2 Bottom runner dirty (due to dirt, foreign particles, lubricant)?

running surfaces!

There must be no dirt on the bottom runner, especially the base element: Wipe dry dirt off with a dry cloth. If there is oil or grease on the runner, you will need to clean the whole element (running surfaces, roller surfaces and rollers), e.g. with glass cleaner. The runner may need to be replaced. **Never use oil or other lubricants on the segments!**

2.1 Bottom runner dirty (due to dirt, foreign particles, lubricant)? Wipe dry dirt off with a dry cloth. If there is oil or grease on the runner, you will need to clean the whole element (running surfaces, roller surfaces and rollers), e.g. with glass cleaner. The runner may need to be replaced. Never use oil or other lubricants on the segments!

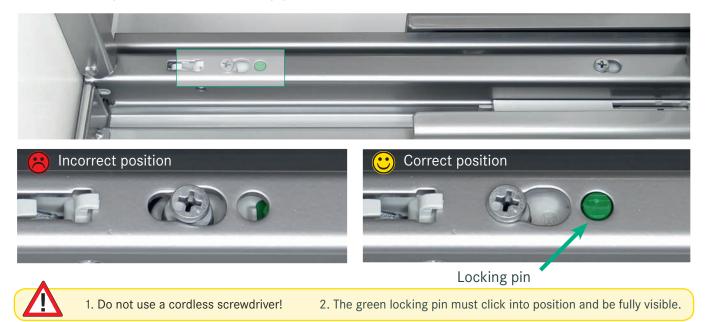
1.3 Faulty connection between the pull-out frame and bottom runner

Check that the pull-out frame is correctly positioned on the bottom runner!

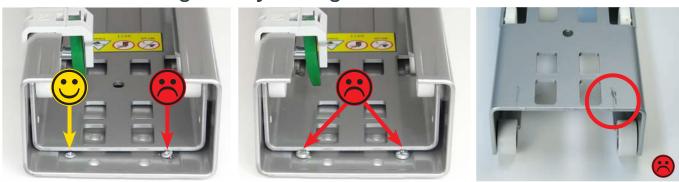
1.5 Are the screws tight? Are you using the correct screws?

1. Do not overtighten the screws!

- 2. The screws used must not come into contact with the middle slide!
- 3. The screws must be straight and firmly tightened (check the middle slide for signs of wear!)
